Tlingit Readers, Inc. - Preservation of Historical and Cultural Landmark

National Historic Landmark
Technical Assistance Program

TABLE OF CONTENTS

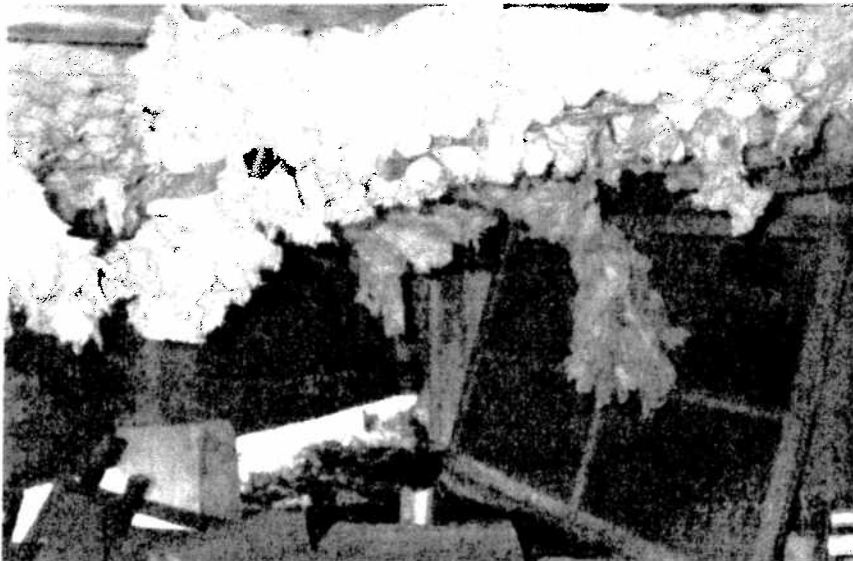
Deteriorated fiberglass insulation hangs loosely in the crawl space.

The foundation is in poor condition due to inadequate seismic bracing. As constructed, the building could easily slide off its existing foundation in the event of a moderate earthquake. There is no indication of seismic bracing or pinning of the wooden posts to the concrete pier foundation. In one location a pier block has settled, but no sag is apparent in the structure above. The foundation is relatively free of rot or deterioration due to moisture. The crawlspace is relatively dry given its slope and the rainforest environment. In most of the areas, the insulation and vapor barrier have been compromised and are not functioning.

1. Construct an engineered foundation to provide adequate seismic bracing. Ensure that the crawlspace is drained to keep the area dry and well ventilated. Install a durable ground cloth (20 mill) at grade to offset rising damp.
2. Remove the existing fiberglass insulation and vapor barrier and reinsulate. Consider using extruded polystyrene insulation and a plywood deck at the underside of the floor structure.

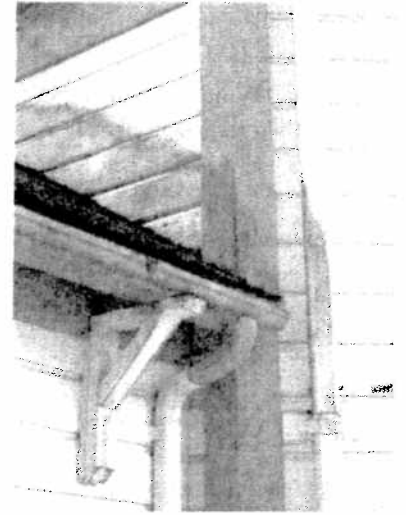
right: Excessive moisture caused by splashback from the main roof drip edge is evident at the intersection of the entry roof and nave wall.

The exterior wall surface and the wall assembly appear to be in good condition. The building seems to be sitting level and plumb with no noticeable deformation or failure. The exterior siding at the narthex north elevation shows signs of damage due to splash-back from uncontrolled roof runoff. Typically, damage in historic building can be expected in areas of ground contact and beneath window sills or horizontal penetrations of the exterior skins. The church is in need of painting.

1. Control ground splash-back; replace deteriorated siding with new to match.
2. Repaint the exterior of the building. Investigate to determine the condition of wall framing beneath the windows and corners.
3. Evaluate the wall assembly and determine the need for insulation.

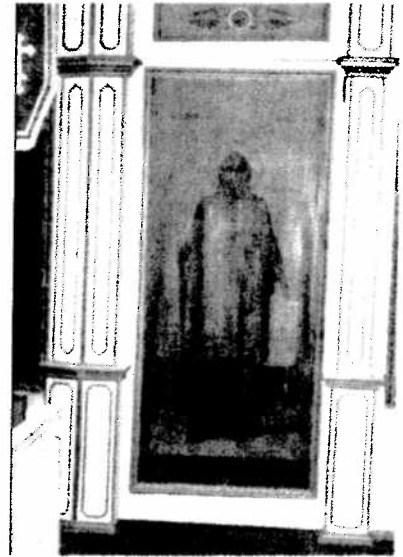
Many of the icons in St. Nicholas Orthodox Church date to the 19th Century and are in need of conservation.

The condition of the icons and historic objects range from poor to fair. Years of little cleaning or conservation care along with an unstable environment are taking their toll on the condition of the artifacts.

1. Document the 35 icons and historic objects in the church. Proceed with conservation treatment by a qualified conservator. Follow established priorities for preservation. Install a mechanical and fire protection systems to provide a stable environment for their long term preservation.

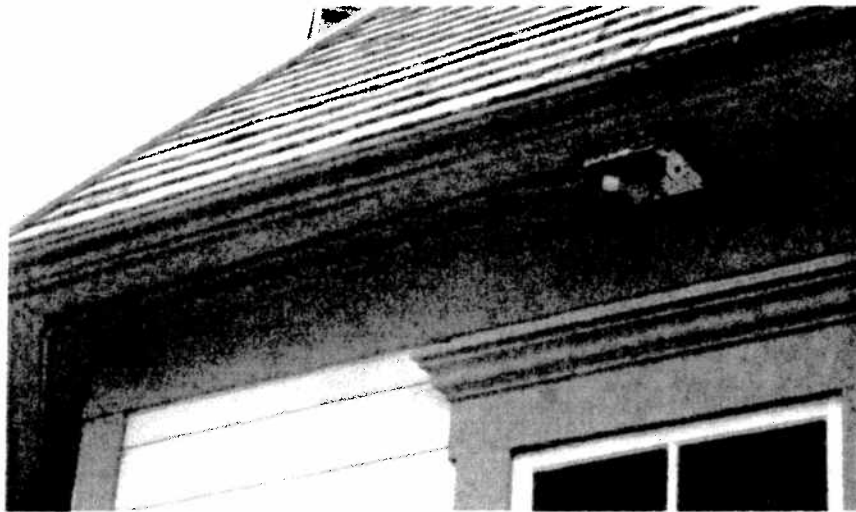
Exposed electrical conduit located under the soffit detracts from the historic appearance of the church.

The existing candelabra is a significant artifact and is in relatively good condition. Exterior soffit lighting is in poor condition due to neglect and the effects of a salt water environment.

1. A short term safety solution which is inexpensive and will reduce the potential for an electrical fire is to replace all building breakers on existing branch circuits rated at 15 and 20 amps with Arc-Fault Circuit-Interrupter (AFCI) devices. The AFCI quickly detects any electrical shorts or arcing due to worn wire insulation, unusual heating or bare wire contact and throws the breaker before a fire can result.
2. Upgrade existing electrical services to meet current electrical codes. Remove all exposed conduit and replace with concealed wiring. Remove all soffit lighting and conduit from the church and relocate on the site using inconspicuous fixtures and landscape elements. Select historic replacement light fixtures for exterior and interior use.

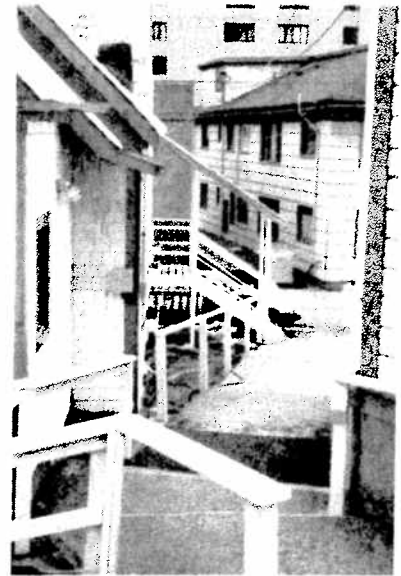
Neither walkway meets ADA requirements and would be difficult for the elderly to access the building. In addition, the concrete walkway is visually incompatible with the historic character of the church and is causing deterioration problems with water splash back.

This concrete sidewalk is not compliant with the Americans with Disabilities Act (ADA) and detracts from the historic appearance of the church.

1. Remove the existing walkways. Research the historic character of the pathways and redesign a new system that is historically sympathetic, meets ADA and uses materials which take their precedence from building's historic period.

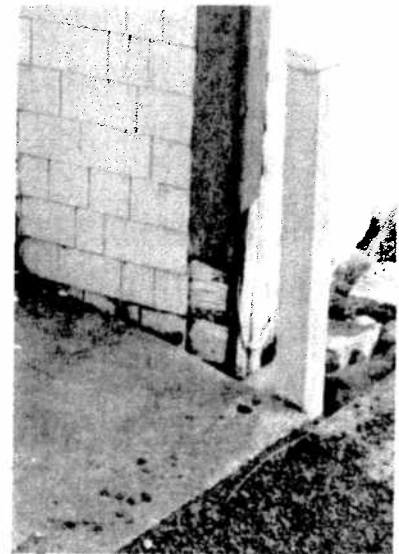
The concrete foundation walls seem to be in good condition, although the extent of steel reinforcement is unknown. Improvements to drainage in front of this area should remedy infiltration of water.

Missing corner boards and siding at the southwest corner of the rectory may be accelerating the deterioration of the foundation.

1. Resolve site drainage issues around the basement foundation. Explore damp proofing and perimeter drainage around foundation. Insulate the interior walls of the basement to correct significant heat losses.
2. Evaluate existing floor framing system and construct new floor framing system to meet loading requirements, to correct structural deficiencies and meet seismic design requirements.

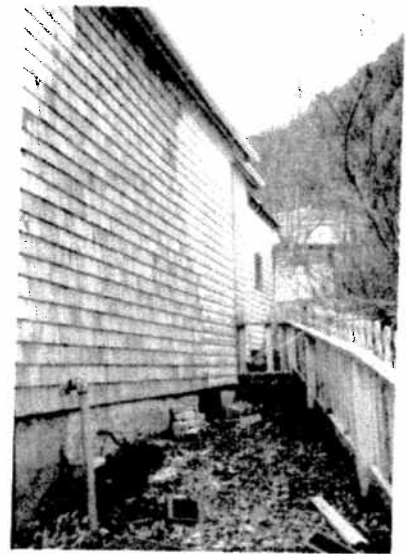
bottom: The recent removal of the chimney from the rectory's east elevation has been patched with cedar shingles.

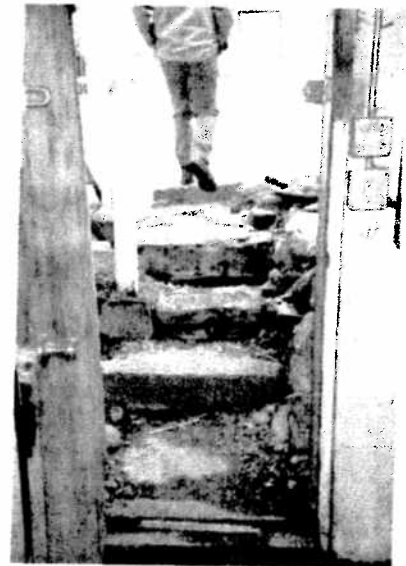
Deteriorated concrete steps to the basement on the rectory's west elevation.
